## CUSTOMER OVERVIEW:

## The Story

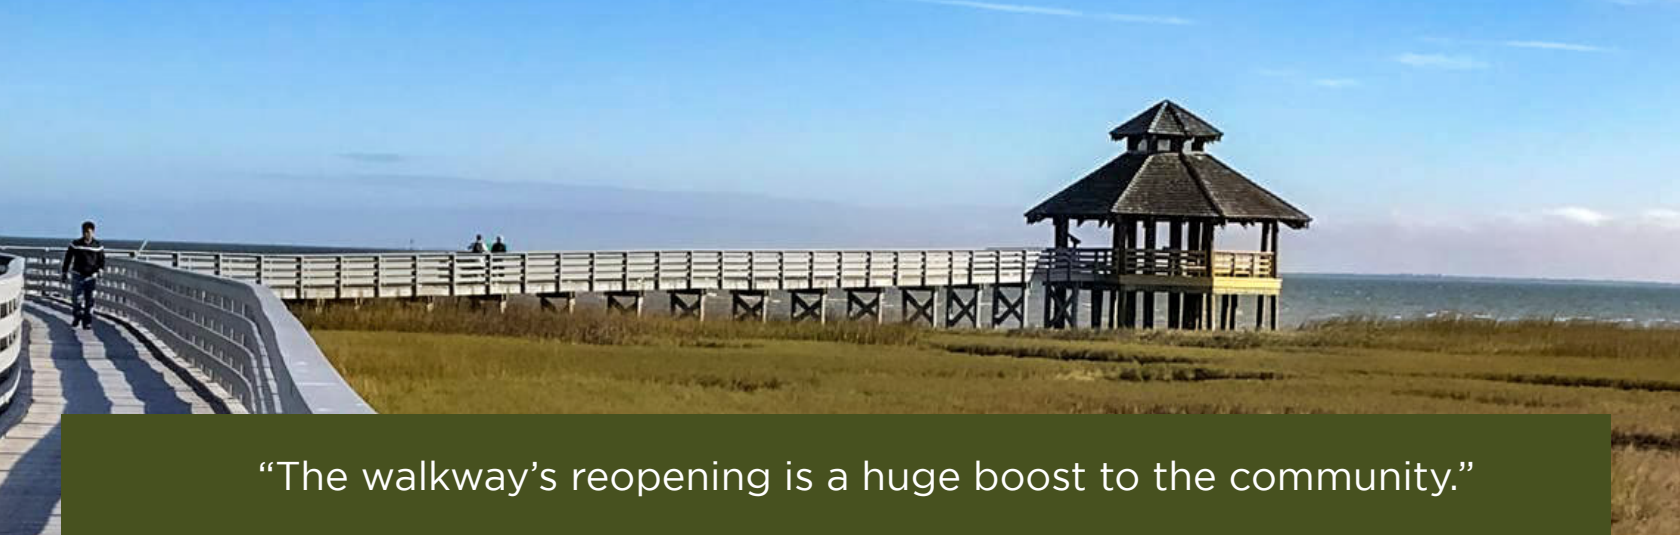
In August 2017, Hurricane Harvey hit the coast of Texas leaving the Walkway and Bird Tower in the City of Port Lavaca almost entirely destroyed and residents devastated. According to WorldVision, Hurricane Harvey ranks as the second-most costly hurricane to hit the U.S. mainland since 1990, causing about \$125 billion in damage. According to the city of Port Lavaca, the hurricane caused 80% of the handrails on the walkway to snap off along with a 30ft long section of the walkway and observation deck on the east side destroyed.

After analyzing the project requirements, it was decided that Tangent Decking and Structural materials would be the perfect material to reconstruct the Wetlands Walkway. Tangent materials were chosen for this project due to its low-maintenance appeal and ability to provide long-lasting strength while remaining aesthetically pleasing. An additional benefit of using Tangent materials was that it can be easily drilled, cut, and installed like traditional wood. The City of Port Lavaca ultimately chose grey Tangent Structural materials as the foundation for the walkway. In addition, the city also used Tangent Structural materials to upgrade the structural support of the walkway including, “2x6 handrail supports were upgraded to 4x4 posts and a 2x10 support was added to the stringer at the connection point to help support each 4x4 post”, according to the City of Port Lavaca’s Facebook page.

The city also mentioned that they used stainless steel screws instead of galvanized screws in the handrail system because of their strength and resistance to rust, helping the screws to last as long as the plastic lumber boards. Furthermore, expansion joints were incorporated into the design to allow expansion and
